RARITAN RIVER BASIN

FARRINGTON DAM

PHASE I INSPECTION REPORT NATIONAL DAM SAFETY PROGRAM

NJ 00383

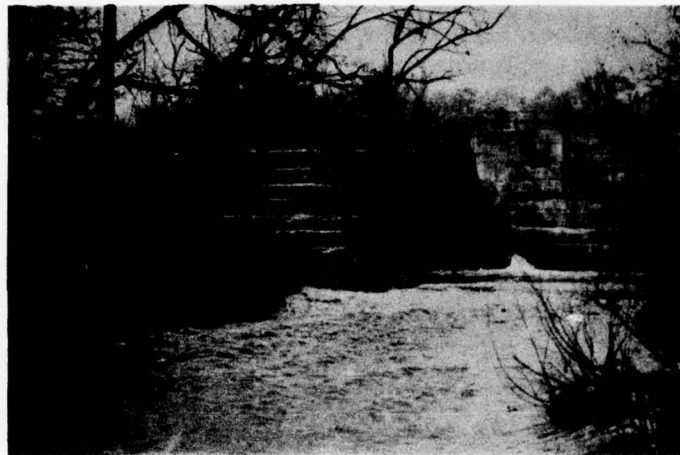
Photo 1 - Downstream face of the dam showing part of the spillway and part of the left non-overflow abutment section; the low level outlet is visible on the right at tailwater level; the downstream channel is partly blocked off by the tree grown peninsula visible on the left of the picture

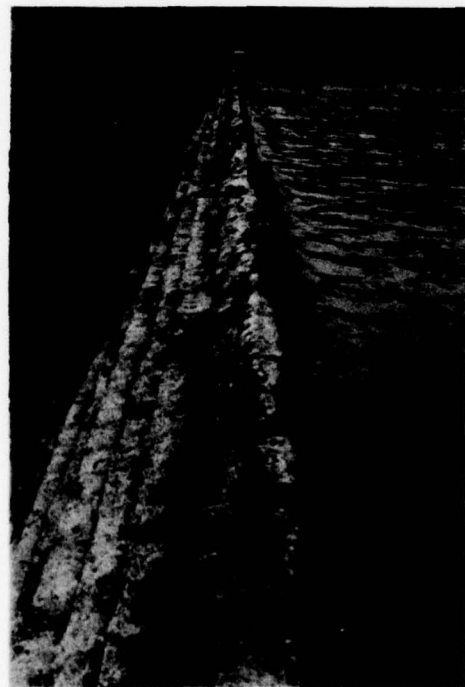
The spillway crest, also apparently repaired, is in slightly better condition than the remainder of the dam face, although also severely eroded. In places, such as adjacent to the left non-overflow section the spillway crest repair concrete, it is completely missing for a distance

Photo 6 - View across the spillway crest of the dam, looking toward the right abutment, showing the deteriorated crest

The rehabilitation of the deteriorated dam spillway crest and facing would be part of such a plan. The low and high level outlet gates should be brought up to full operational capacity within six months.

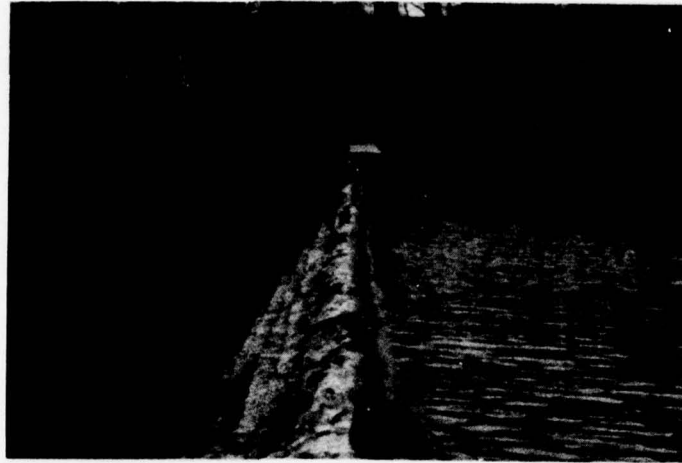
Photo 7 - Detail of the spillway crest at the right non-overflow abutment section

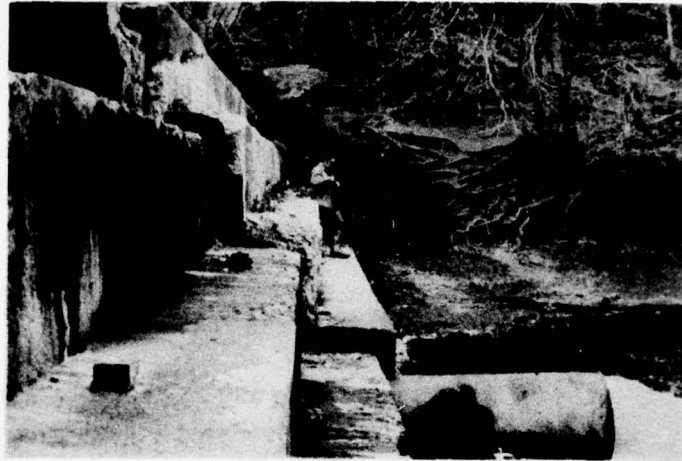
The dam abutment on the left is steep and leaking near the top. The slope is surface eroded, exposing tree roots on the abutment slope downstream of the dam. The right abutment is less steep, but also leaks, with the leakage forming a small rivulet downstream of the dam.

Photo 9 - View of the lower left abutment area downstream of the dam

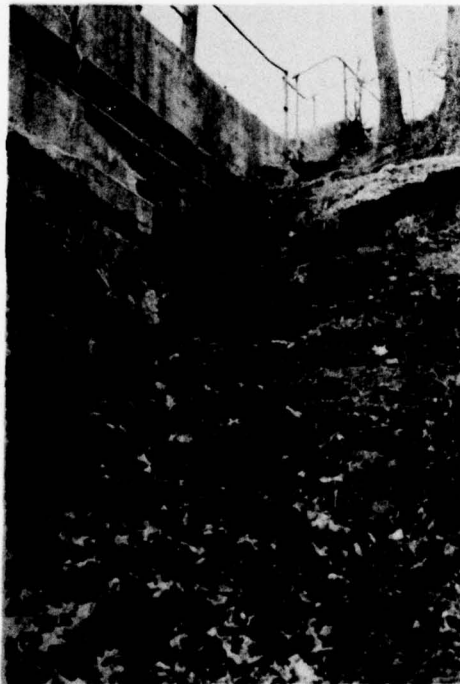
Seepage was observed coming out high up on the left abutment's downstream face, approximately at the reservoir level and estimated at one gallon per minute.

Photo 10 - View of the upper left abutment area downstream of the dam showing the general area of seepage at the top of the dam

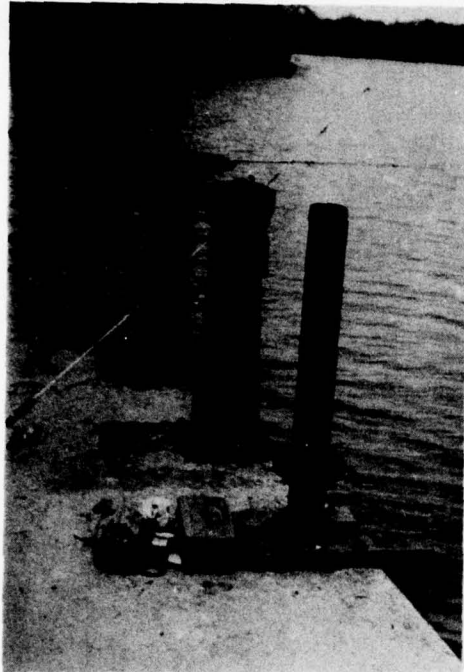
In summary, Gate 3 is operable and in good condition; Gate 1 is inoperable; however, the desirability of repair is debatable since the centerline elevation of this intake is only two feet below the crest of the spillway. Gate 2 has been unused for years and may be inoperable. Without this gate, the reservoir can be drawn no lower than approximately elevation 37.0, which is the invert elevation of the mid-level outlet Gate 3.

Gate No. 1 (high level) has a missing operating stand and is inoperable. Gate No. 2 has not been operated in years and is assumed to be inoperable. Gate No. 3 (mid-level) is operable.

Photo 13 - Close-up of the outlet works gate operating stands; only the far stand, controlling the middle gate is readily operable

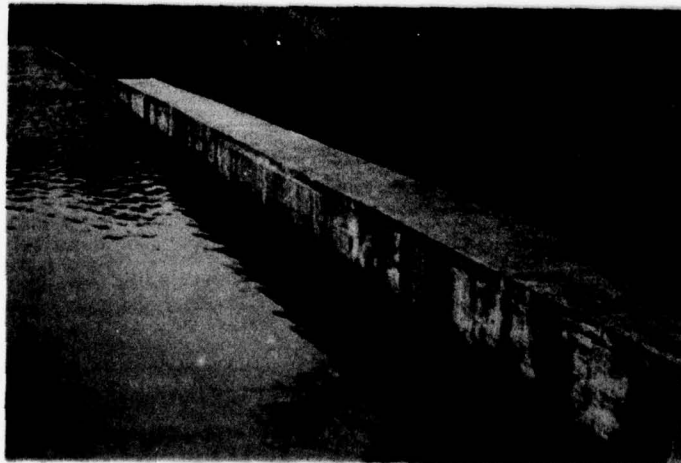
Photo 14 - Upstream view of the right abutment non-overflow abutment section

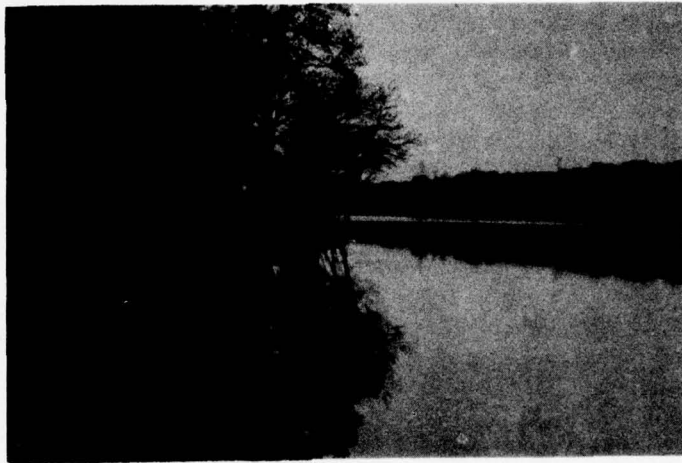
Photo 17 - View of the right reservoir rim looking upstream from the dam
